# Integrated Functional Appraisal (IFA) Nuclear Science Division

June 30, 2005

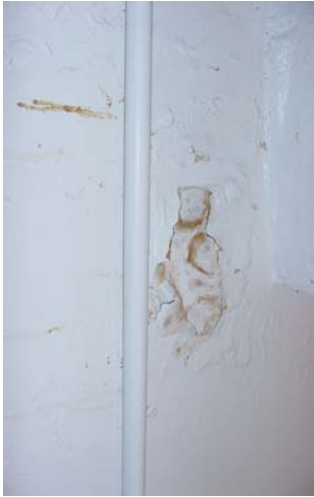
Fig. 1. Building 88, Cave1: Damaged/peeling lead based paint on the wall at the cave entrance at the seismic joint.

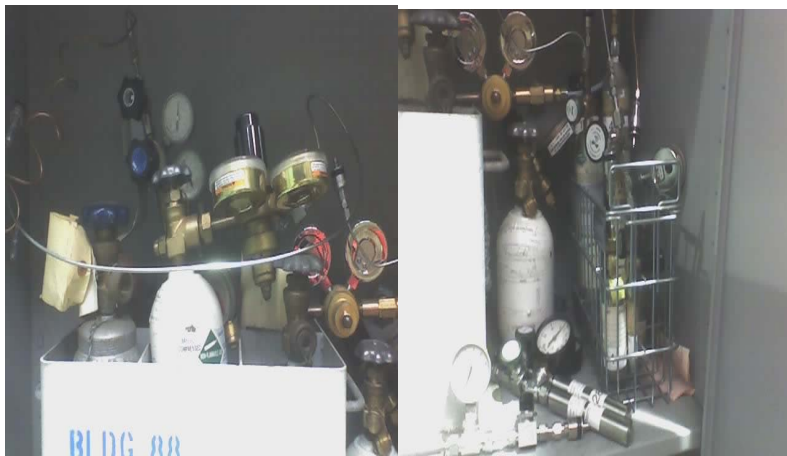
Fig 2. Building 88, Cave Roof (VENUS area): Inappropriate storage of gas cylinders under PNL-012-88. Some cylinders have regulators attached and others have caps.

88	Cave Roof (Outside BGS shack)	Chairs have unsafe leg configuration (four rather than five casters).	Discard unsafe chairs.
88	Cave Roof (Outside BGS shack)	Access to an elevated platform was provided using a modified ladder stand instead of a fixed ladder or a stair case. The ladder stand lacks the required weight rating for stairs, and the top step is much higher than other steps, creating multiple OSHA violations.	Replace the ladder stand with a fixed ladder or with a Lapeyre stair ( <a href="http://www.lapeyrestair.com/">http://www.lapeyrestair.com/</a> ).
88	Cave Roof	Inappropriate storage of gas lecture bottles. Some bottles have regulators attached and others have caps.	Establish which cylinders are in use and which are in storage. If in storage, caps are required & regulators must be removed. Cylinders must be secured.

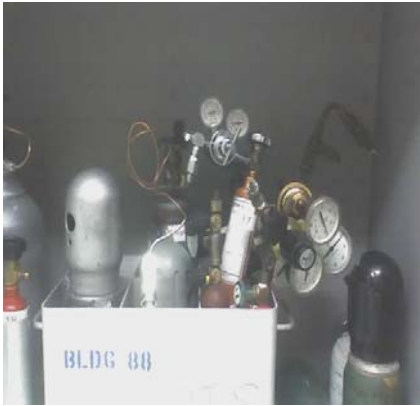
Fig. 3. Building 88, Cave Roof: Inappropriate storage of gas lecture bottles. Some bottles have regulators attached and others have caps.
